管継手は水圧と共生する内

Rehabilitate and maintain pipe joints with water pressure cautious

面バンドで再生・保全

Internal Band

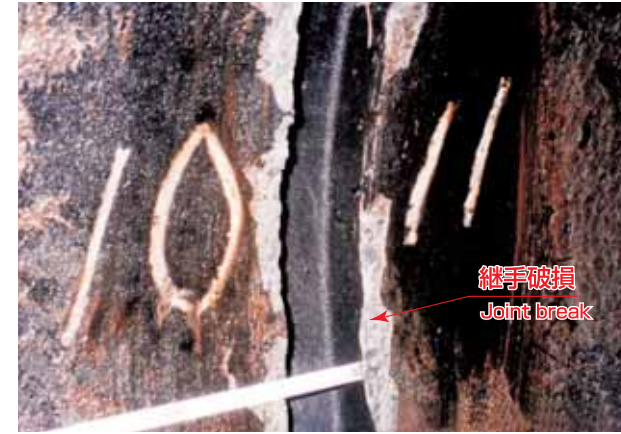
地震時には管継手は衝突の繰り返しで漏水

During the earthquake, pipe joint suffers repeated collision and result in water leakage

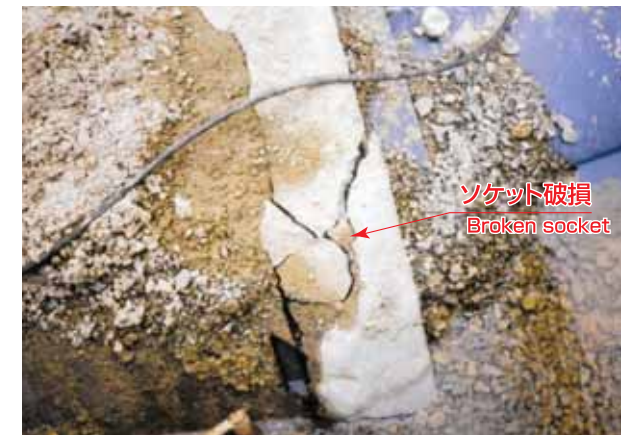
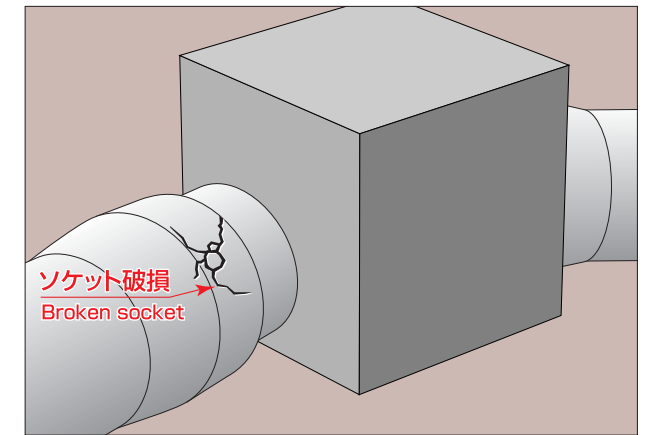
地震時には曲管部に集中応力が作用し管破損漏水

During the earthquake, the stress concentration acts at bend pipe area and cause pipe break water leakage

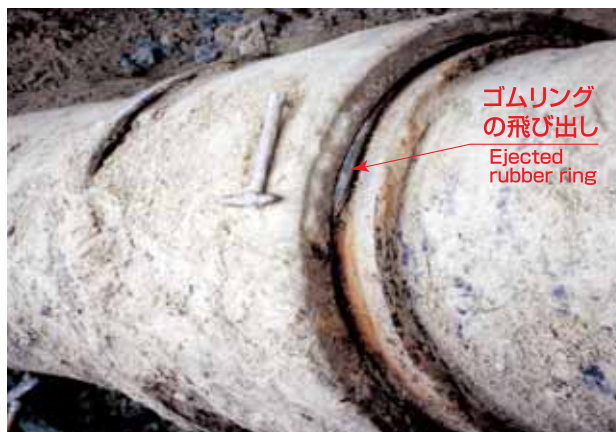
ゴム反力低下で水圧によりゴムリング飛び出し漏水

With decline of rubber reaction, rubber ring is ejected to cause water leakage

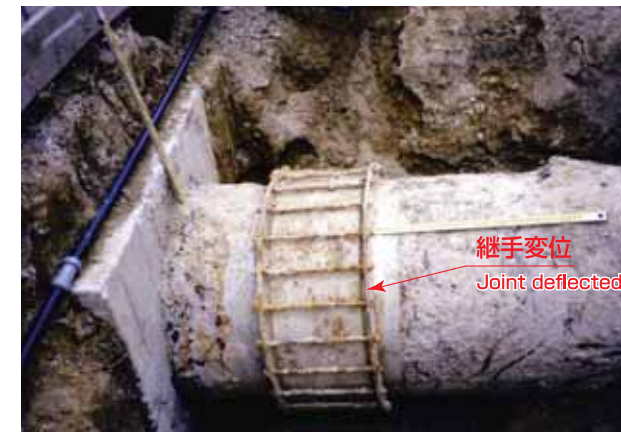
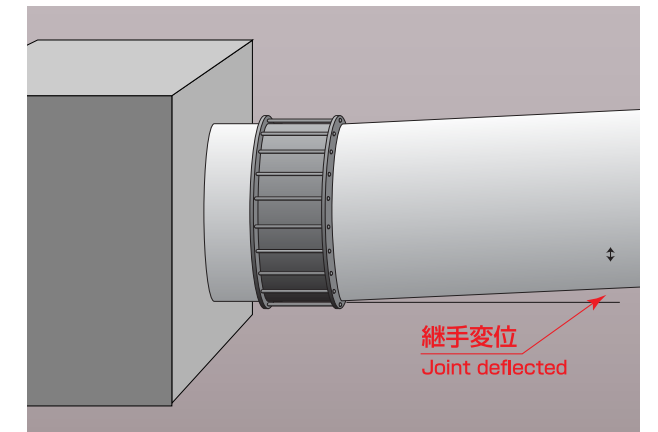
構造物付近の管継手は不等沈下で漏水

Pipe joint near the structure suffers uneven settlement and result in water leakage
