# 内面バンドによる管接合及び管補修事例

Examples of pipe connection and pipe repair with internal surface band

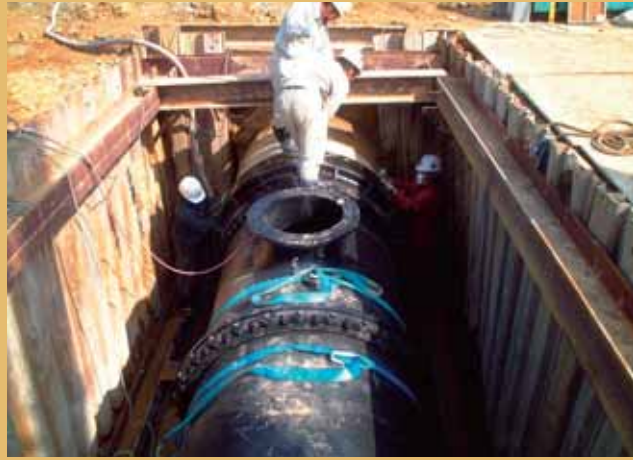
## 1 ダクタイル鋳鉄製マンホール管とPC管接合 (φ1500) Ductile cast iron manhole pipe and PC pipe connection (φ1500)

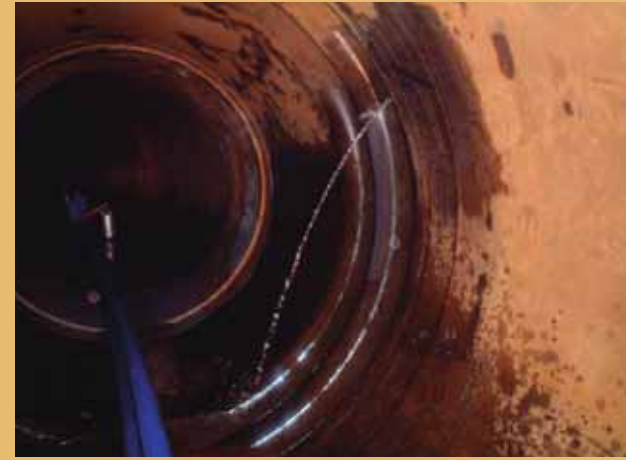
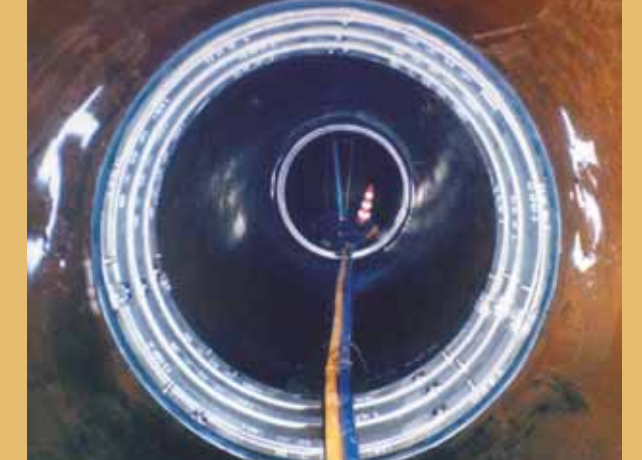
## 4 鋼製可撓管の電蝕漏水補修 (φ1500・水圧1MPa) Repair of water leakage on electric corroded steel flexible pipe (φ1500, water pressure 1 MPa)

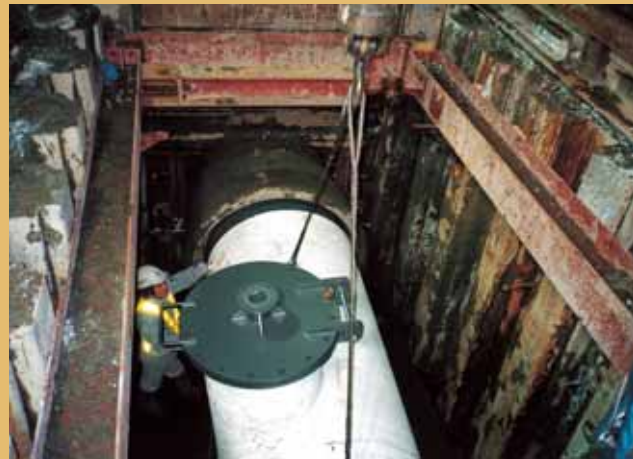
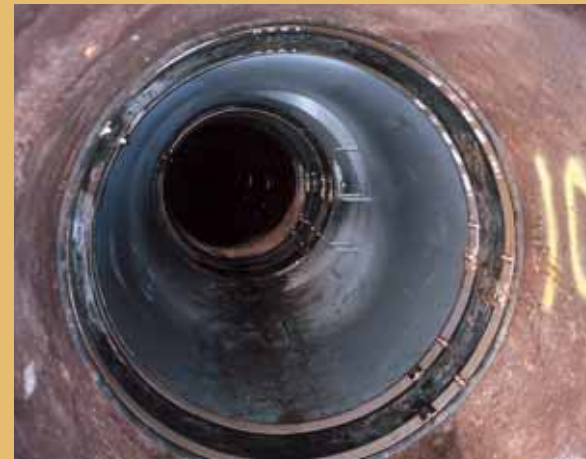
## 2 鋼製マンホール管とPC管の接合 (φ1200) Steel manhole pipe and PC pipe connection (φ1200)

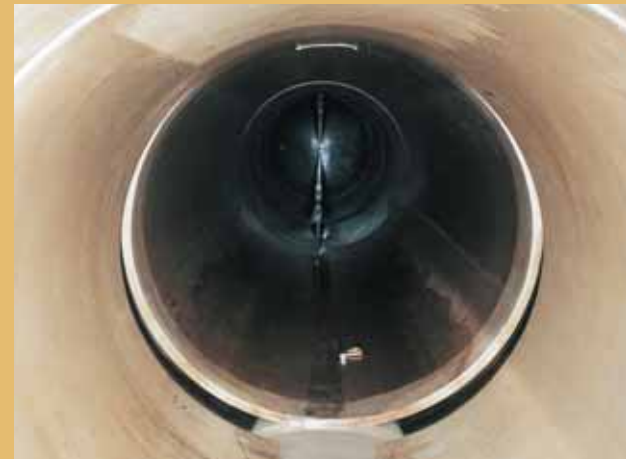
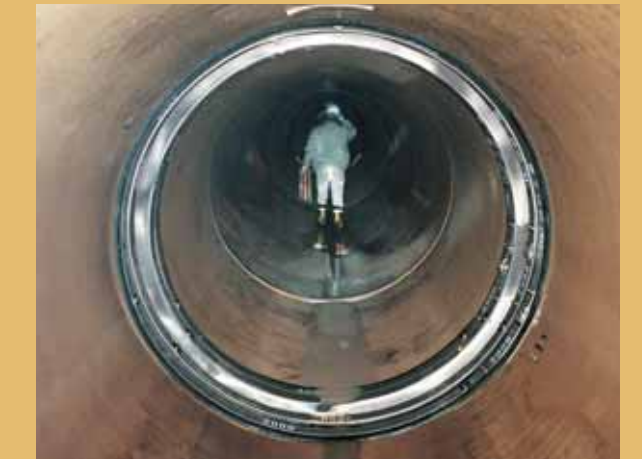
## 5 FRPM管の継手間隔260mm、段差59mmの接合 (φ2000) Connection of FRPM pipe with joint gap 260 mm, deviation 59 mm (φ2000)

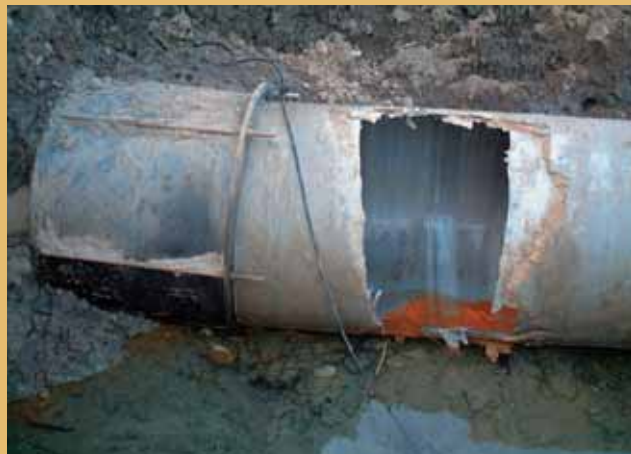
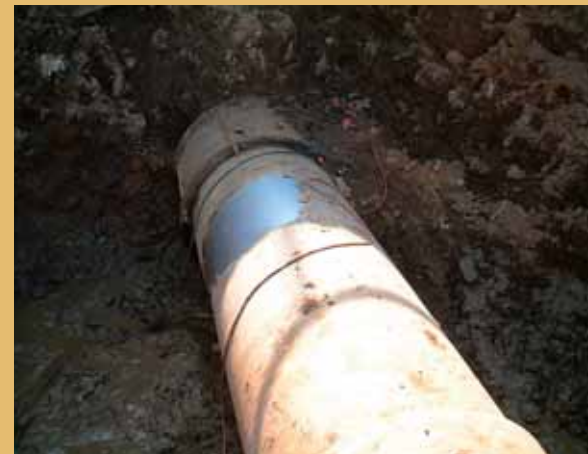
## 3 破裂FRPM管の内面バンド管更生工法 (φ800・水圧0.5MPa) Internal Band rehabilitation method for burst FRPM pipe (φ800, water pressure 0.5 MPa)

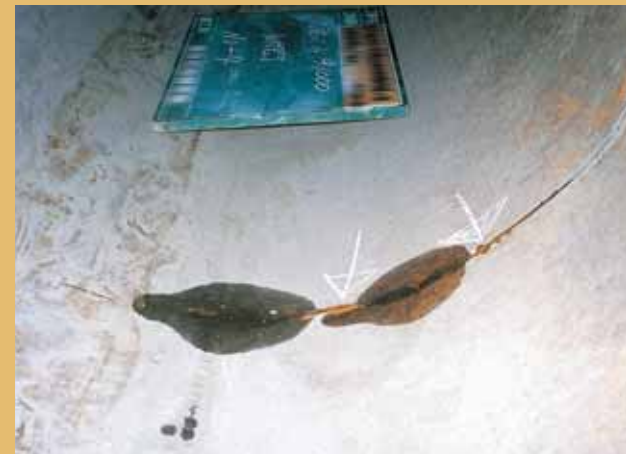
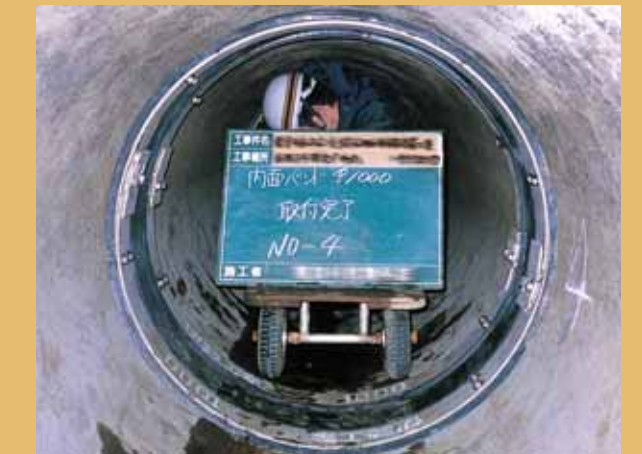
## 6 被覆樹脂管のPC管継手部の亀裂補修 (φ1000) Crack repair of resin coated PC pipe joint (φ1000)
